REPAIR, EVALUATION, MAINTENANCE, AND
REHABILITATION RESEARCH PROGRAM

TECHNICAL REPORT REMR-CO-1

STABILITY OF RUBBLE-MOUND
BREAKWATER AND JETTY TOES;
SURVEY OF FIELD EXPERIENCE

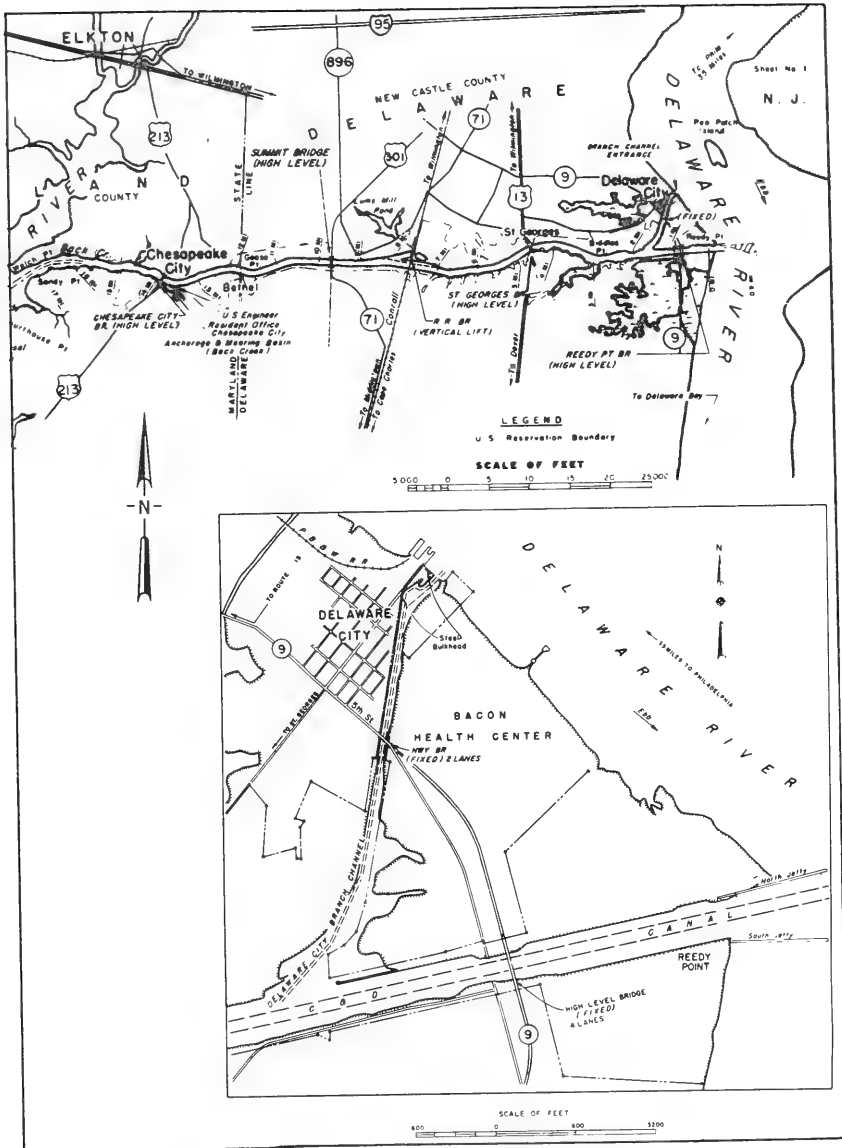
Figure 28. Reedy Point Jetties, Delaware

26. The jetties located at Reedy Point, where the Chesapeake and Delaware Bay Canal intersects the Delaware River, were originally constructed prior to 1938 (Figure 28). Both structures were of rubble-mound construction. In the 1960's the existing south jetty was removed, and a new south jetty was constructed farther south. This was done to increase the entrance size to accommodate larger vessels and improve navigation safety. The present jetties are both 2,095 ft long, and it was reported that the north jetty has problems with toe scour, loss of armor stone, and overall subsidence.

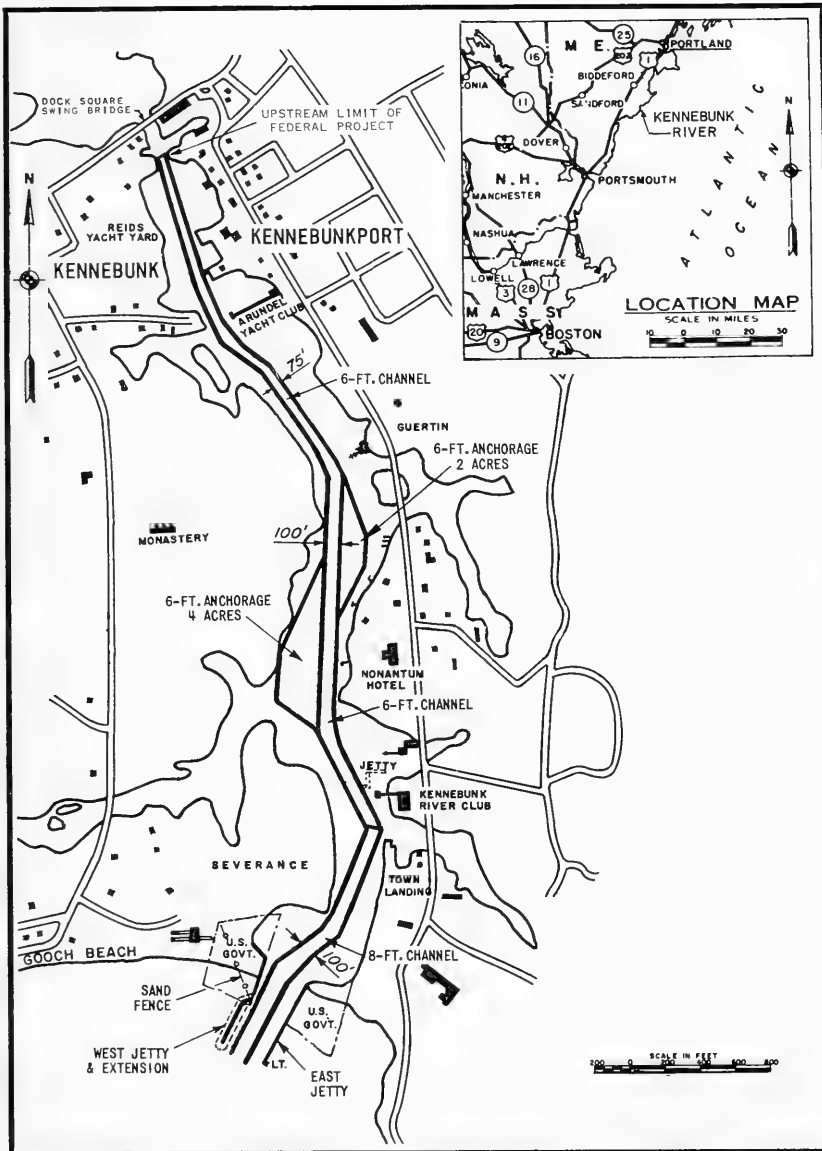
Figure 30. Kennebunk River Jetties, Maine

28. Based on review of historical repair data, it appears that three project sites within the New England Division that contain rubble-mound jetty structures have exhibited stability problems which could be related to instability of the structure toes. Both jetties at the mouth of the Kennebec River, Maine (Figure 30), have a history of extension and repair. The latest jetty rehabilitation work was completed in 1982. Recent inspections show that both jetty heads are damaged and that 250 ft of the channel side of the east jetty have been undermined. The most recent inspection reports (1973-74), indicate that the north and south jetties at Newburyport Harbor, Massachusetts

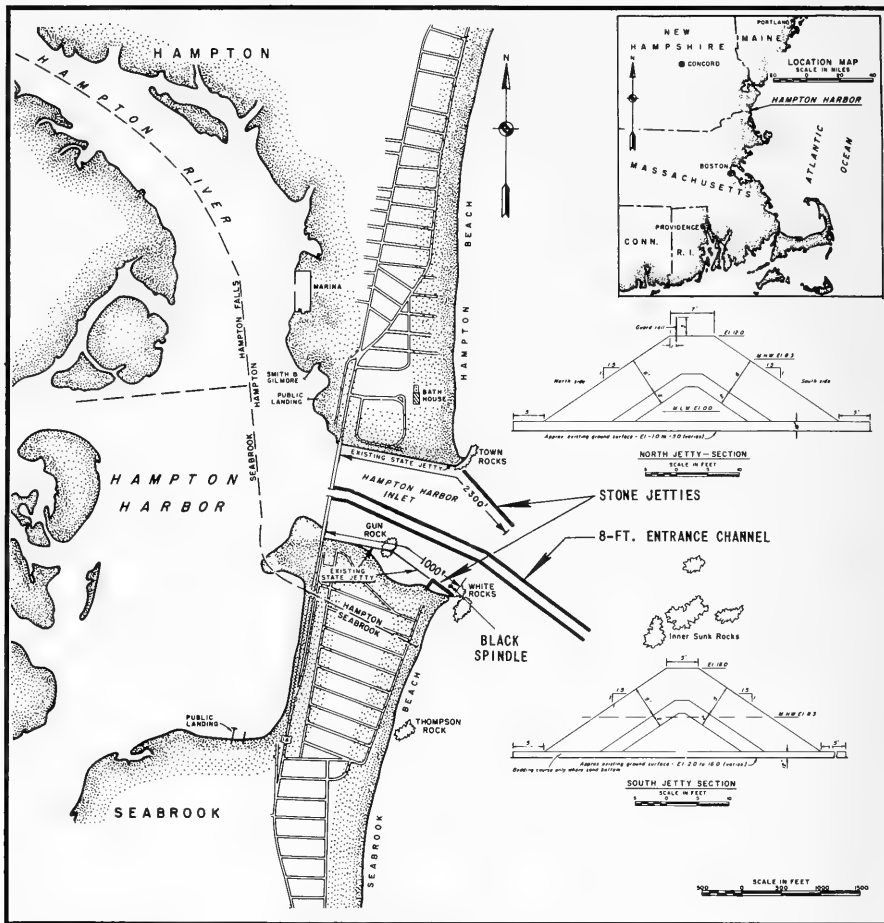
Figure 32. Hampton Harbor Jetties, New Hampshire

(Figure 31), which have an extensive repair and rehabilitation history, are showing considerable damage. This damage appears to result primarily from subsidence. Damage on four areas on the channel side of the south jetty most likely result from undermining of the rubble toe. The jetties at Hampton Harbor, New Hampshire (Figure 32), were originally constructed by the State and were turned over to the Corps in 1964. During 1965 to 1966, considerable work was done on both jetties. Since that time the south jetty has remained in good condition, while the north jetty has required continuous maintenance. Most of the repair and rehabilitation work has been needed on the seaward portions of the north jetty. The last rebuilding of the north jetty was completed in 1980, and it is thought that part of this recurring damage can be attributed to scour and undermining of the jetty toe.

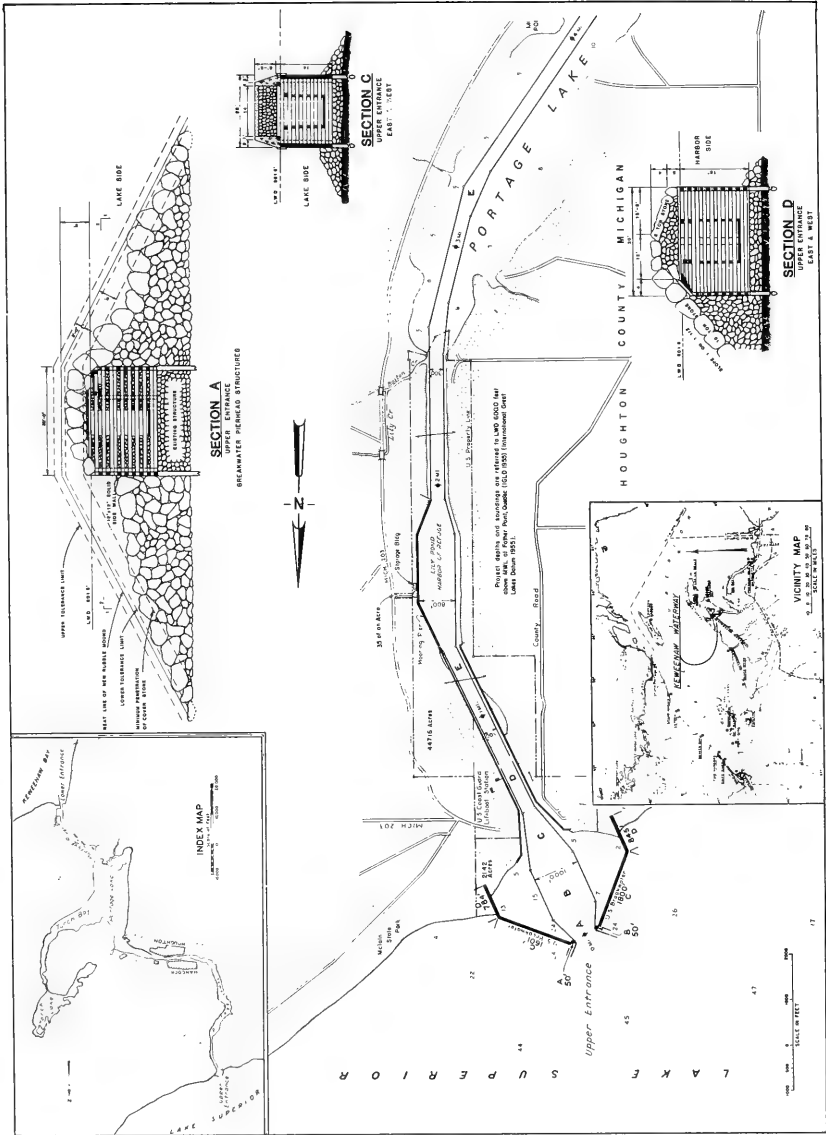
Figure 56. Upper Entrance Breakwaters, Keweenaw Waterway, Michigan

rubble-mound structure. The remainder of the structures at Keweenaw are timber crib with some rubble and steel sheet piles.
